# CALLBACK

From NASA's Aviation Safety Reporting System

Number 233

November 1998

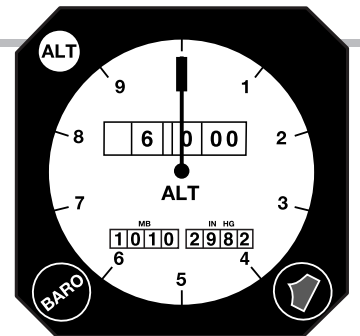
■ *After we leveled at 11,000 feet, Center said to descend and maintain 11,000 feet. We replied that we were level at 11,000 feet. About a minute later, Center again said to descend and maintain 11,000 feet. They said they showed us level at 12,000 feet and pointed out traffic at 13,000 feet. About that time, we discovered that the altimeters were set to 28.88 instead of the proper setting of 29.88. We quickly descended to 11,000 feet.*

*The night before, maintenance personnel had dialed both altimeters back to sea level...[the actual] field elevation is approximately 1,000 feet MSL. We accomplished all checklists on preflight, but failed to notice that the second digit [of the barometric setting indicator] had been set to an 8 instead of a 9. This is something that is easy to miss.*
