# CALLBACK

From NASA's Aviation Safety Reporting System

Number 337

## Out-of-the-Ordinary Incidents from ASRS Files

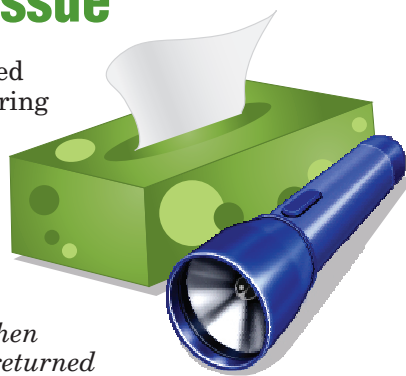
A CRJ700 Captain reported jammed rudder pedals during a takeoff.

■ *While taking off...and at about 50-60 knots, the left rudder jammed and I rejected the takeoff. We made a full stop prior to crossing Runway 23. We then cleared the runways and returned to the ramp to troubleshoot the problem.*

*After we were clear of the runway, I saw a small tissue box under the rudder pedal. This box apparently was already forward of the rudder pedals out of sight when we took over the aircraft. When takeoff power was applied, the tissue box slid back under my foot and rudder pedals causing the rudder to jam. Directional control was difficult but maintained during the rejected takeoff maneuver.*

Tissue boxes, flashlights, water bottles, and manuals have all managed to interfere with rudder travel. Usually a visual preflight and a flight control check will detect these objects prior to takeoff. Flight crews should make sure that items that go missing during flight are located prior to turning the aircraft over to the next crew.

*This was our first flight in this aircraft for the trip. Make sure all crews ensure the floor around the pilots seats are clear and that no foreign objects can slide forward on landing, jamming the rudders.*
