CALLBACK

From NASA's Aviation Safety Reporting System

Number 284

The Case of the Unstable Approach

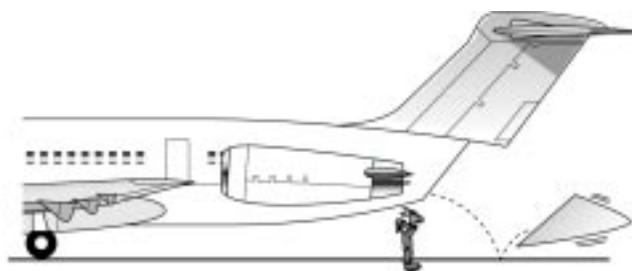
Although it might seem unlikely that anyone would confuse the MD80/90 tail cone jettison with the aft passenger door/stair operation, two incidents reported to ASRS confirm what Mr. Murphy said, "If it can be done wrong, it will be done wrong."

■ *Ramp personnel told us that there was no passenger stair available and that they could not fuel the aircraft with passengers on board unless an exit door was available. Someone on the ground asked about lowering the aft stairs.... We found the procedure for exterior aft stair operation in the aircraft manual. We gave the ramp personnel the page from the manual. They had no questions and indicated that they could do the procedure.... They pulled the emergency jettison handle and jettisoned the tail cone.*

■ *[We] taxied to the maintenance ramp for a one-hour ATC and weather delay. Six passengers deplaned via the aft stair because they did not wish to continue due to the delay. The First Officer thought that you could raise the stair from inside the cabin. I went aft and while I was looking at the panel, the Number Two Flight Attendant, trying to help, pulled the handle above the emergency exit door releasing the tail cone. The tail cone fell to the ground causing some damage....* ▲
