CALLBACK

From NASA's Aviation Safety Reporting System

March 2010

PILOT and ATC "Cones of Confusion"

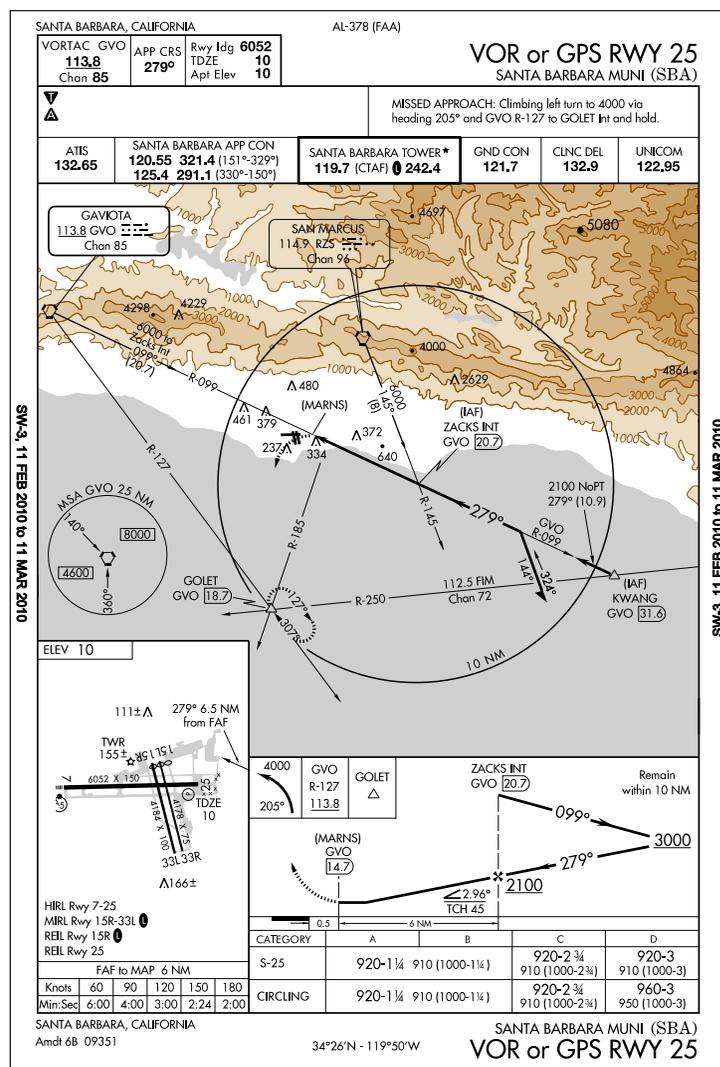
Seems clear enough, doesn't it? But here's what happened to a GA pilot flying the SBA (Santa Barbara, California) VOR/GPS 25 approach in IMC:

■ *On IFR clearance to SBA. Final waypoint in that clearance is KWANG, from which a straight-in approach via the SBA VOR/GPS 25 approach is indicated. Received radar vectors for sequencing prior to KWANG, then "proceed direct ZACKS (the FAF and also an IAF), maintain 2,100 until established, cleared GPS 25 approach." Shortly thereafter, I was instructed to contact the Tower. Per AIM 5-4-9, a procedure turn is required with this clearance. ATC provided no radar vector to intercept the final approach course, nor did ATC assign a "straight-in approach." Considered as an IAF, ZACKS does not have a "NoPT" indication, vs. KWANG, which does. The fact that the assigned altitude (2,100 feet) was below the 3,000 foot floor of the outbound procedure turn segment aroused my suspicion. I queried the Tower Controller, who informed*

me not to perform the course reversal and proceed straight in. I was able to do so safely and landed without incident.

In my opinion, this misunderstanding could have resulted in a very serious situation. Were another aircraft cleared straight-in for the same approach behind me, and had I performed the course reversal, there would have been two aircraft, in IMC, heading in opposite directions, at the same altitude, following the highly precise GPS course.

In discussions with others, confusion over procedure turns in radar and RNAV environments seems surprisingly common, both among pilots and controllers... Perhaps ATC should consider including "cleared via straight in" or "cleared via procedure turn" in all approach clearances to obviate similar misunderstandings.

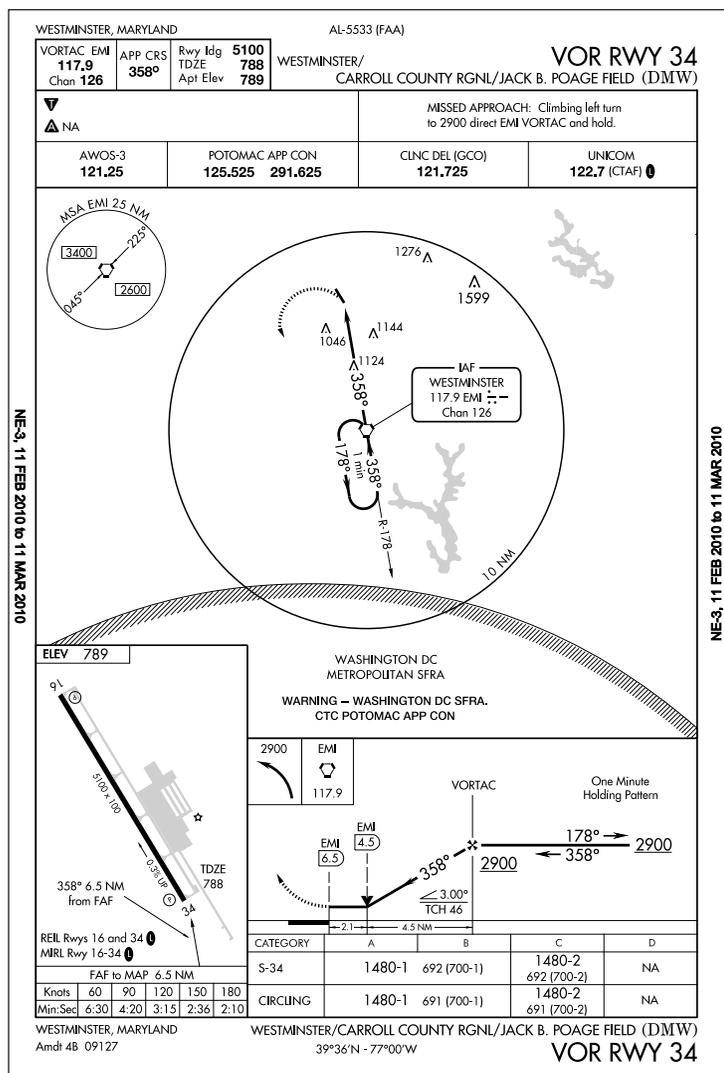
A Cessna 182 pilot flying a non-precision approach to DMW (Carroll County Regional Airport, Maryland) experienced the same "cone of confusion" as the pilot in Situation #1 when attempting to comply with the published requirement for a course reversal. The flight was in IMC.

■ *I was on a short 20-minute flight to DMW. After receiving several vectors for traffic flow, I was cleared direct to EMI, the IAF for*

the approach, when I was about 10 nm away from the VOR. The controller subsequently cleared me for the VOR Runway 34 approach at DMW, and I proceeded to execute the hold-in-lieu-of-a-procedure-turn per the published procedure. While I was on the outbound leg of the hold, the controller told me that he 'did not clear me for the procedure turn,' and told me that he needed me to turn inbound right away. I immediately complied, and completed the approach.

I believe I was executing the approach properly, per the guidance stated in the AIM, but it was distracting and concerning when there seems to be a disconnect between what I as the pilot believes should be flown, and what the controller believes should be flown in terms of the approach. In my limited experience flying IFR, there seems to be a continued confusion between pilots and ATC regarding whether or not the hold-in-lieu-of-a-procedure-turn should be flown. This confusion is especially distracting to a pilot who must remain focused on flying a non-precision approach in IMC...

ASRS called this pilot back to ask for more details. The pilot stated that the Approach Controller was busy and reacted strongly when the approach wasn't flown straight in. The words "straight in" were not part of the approach clearance. A local FAA designated check airman later concurred with this pilot's understanding of the procedures involved.

The guidance is straightforward: If vectors are not being provided, and you are cleared direct to the IAF, then fly the entire approach as published.

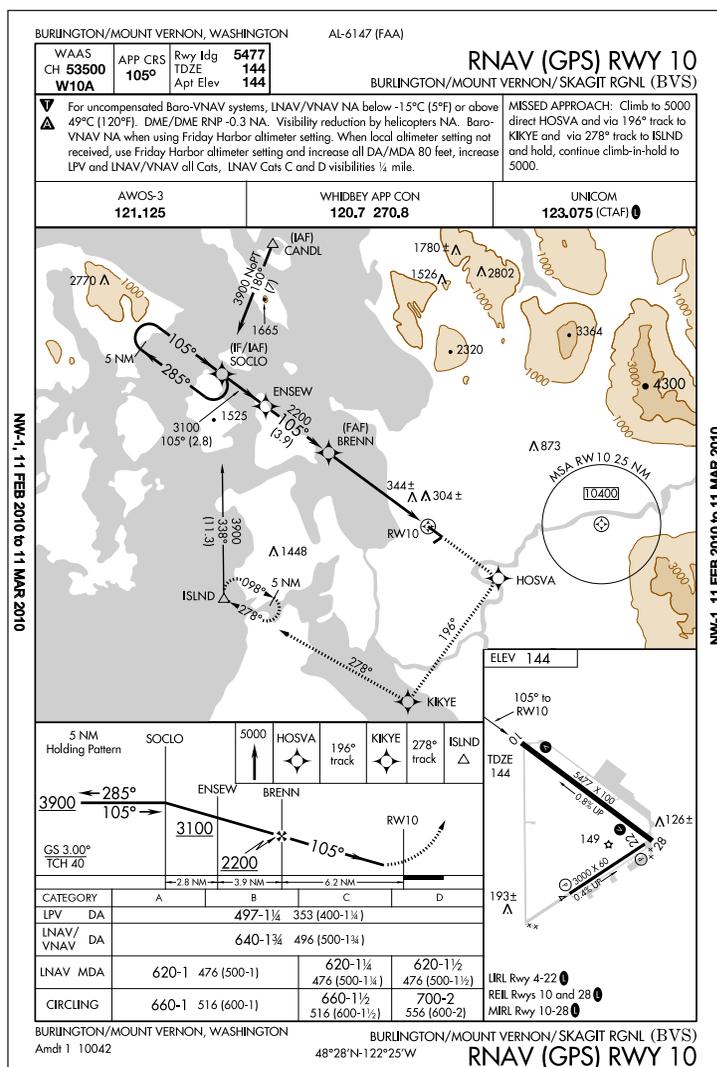
■ We were en route to BVS [Skagit County Regional Airport, Washington] for an approach RNAV Runway 10. ATC cleared us direct to SOCLO intersection, the IAF. We were on a north heading. A clearance was later given to cross SOLCO intersection at 4,000 feet and cleared for the RNAV 10 approach. Since we were at 4,000 feet and the initial altitude for the approach was 3,900 feet and we were not on a transition, we assumed...to be cleared for straight-in. At SOLCO we turned inbound and resumed the approach without entering the procedure turn. Whidby Approach informed us that we were not cleared for a straight-in and that we should have conducted the full approach.

The problem could have been avoided and I think that complacency was the main factor. We do numerous approaches yearly and when we are flying at the initial altitude and being vectored or cleared to a fix, ATC always clears us for a straight-in approach. Lesson learned is that always ask when in doubt.

This reporter's advice brings us full circle to the AIM. The note to section 5-4-9-a adds: "If the pilot is uncertain whether the ATC clearance intends for a procedure turn to be conducted or to allow for a straight-in approach, the pilot shall immediately request clarification from ATC (14 CFR Section 91.123)."
