**The Ohio State University
Eighth International Symposium on Aviation Psychology**

***Airport Ramp Safety and Crew
Performance Issues***

This study examined 182 ramp operations incident reports from the Aviation Safety Reporting System (ASRS) database, to determine which factors influence ramp operation incidents. It was found that incidents occurred more often during aircraft arrival operations than during departure operations; incidents occurred most often at the gate stop area, less so at the gate entry/exit areas, and least on the ramp fringe areas; and reporters cited fewer incidents when more ground crew were present. The authors offer suggestions for both airline management and flight crews to reduce the rate of ramp incidents.

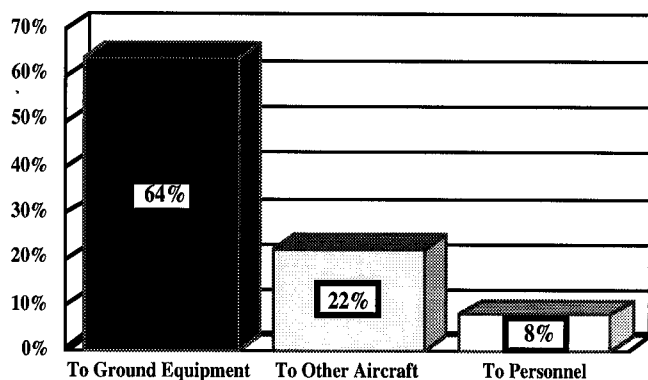
Ground equipment, and by association, ground personnel, appear to be most vulnerable to damage or injury in ramp operation incidents. Ground equipment in general was the clear "loser" in the reported incidents, as depicted in Figure 2. Damage to ground equipment occurred most often in the gate stop area, less so in the gate entry/exit areas, and rarely on the ramp fringes.

Figure 2. Types of Ramp Damage and Injury

Damage to another aircraft was cited in 22% of the reports. Interestingly, other aircraft were usually damaged in the ramp and gate entry/exit areas, where the taxiing aircraft were sharing a common maneuvering area and were likely to be in radio contact with a controlling agency. Damage at the gate stop area was less common.

Injury to personnel was reported in 8% of the incidents, and two-thirds of those injured were specified as ground crew members. Fortunately, this is a small percentage. Although it is not a substantial-looking number, it obviously represents a substantial impact in the lives of the persons who were injured. This number also represents a
