CALLBACK

From NASA's Aviation Safety Reporting System

Number 274

June 2002

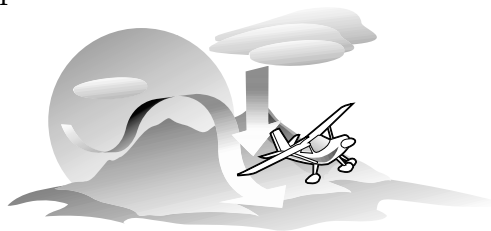
Mountain wave conditions occur when air blowing across the upwind side of a mountain range (generally the western side) creates an updraft that is transformed into a turbulent downdraft as the air passes the crest of the ridge. The downdrafts encountered during “wave” conditions can easily exceed the climb capability of aircraft, and are often accompanied by severe turbulence. In the Western U.S., wave conditions often extend hundreds of miles downwind of a mountain range.

Mountain waves can affect *any* aircraft and create a situation where aircraft and pilots are “along for the ride.” More from this A320 Captain’s report to ASRS:
