NASA Technical Memorandum 81252

**NASA Aviation Safety  
Reporting System:  
Quarterly Report No. 12**

Ames Research Center  
Moffett Field, Calif. 94035

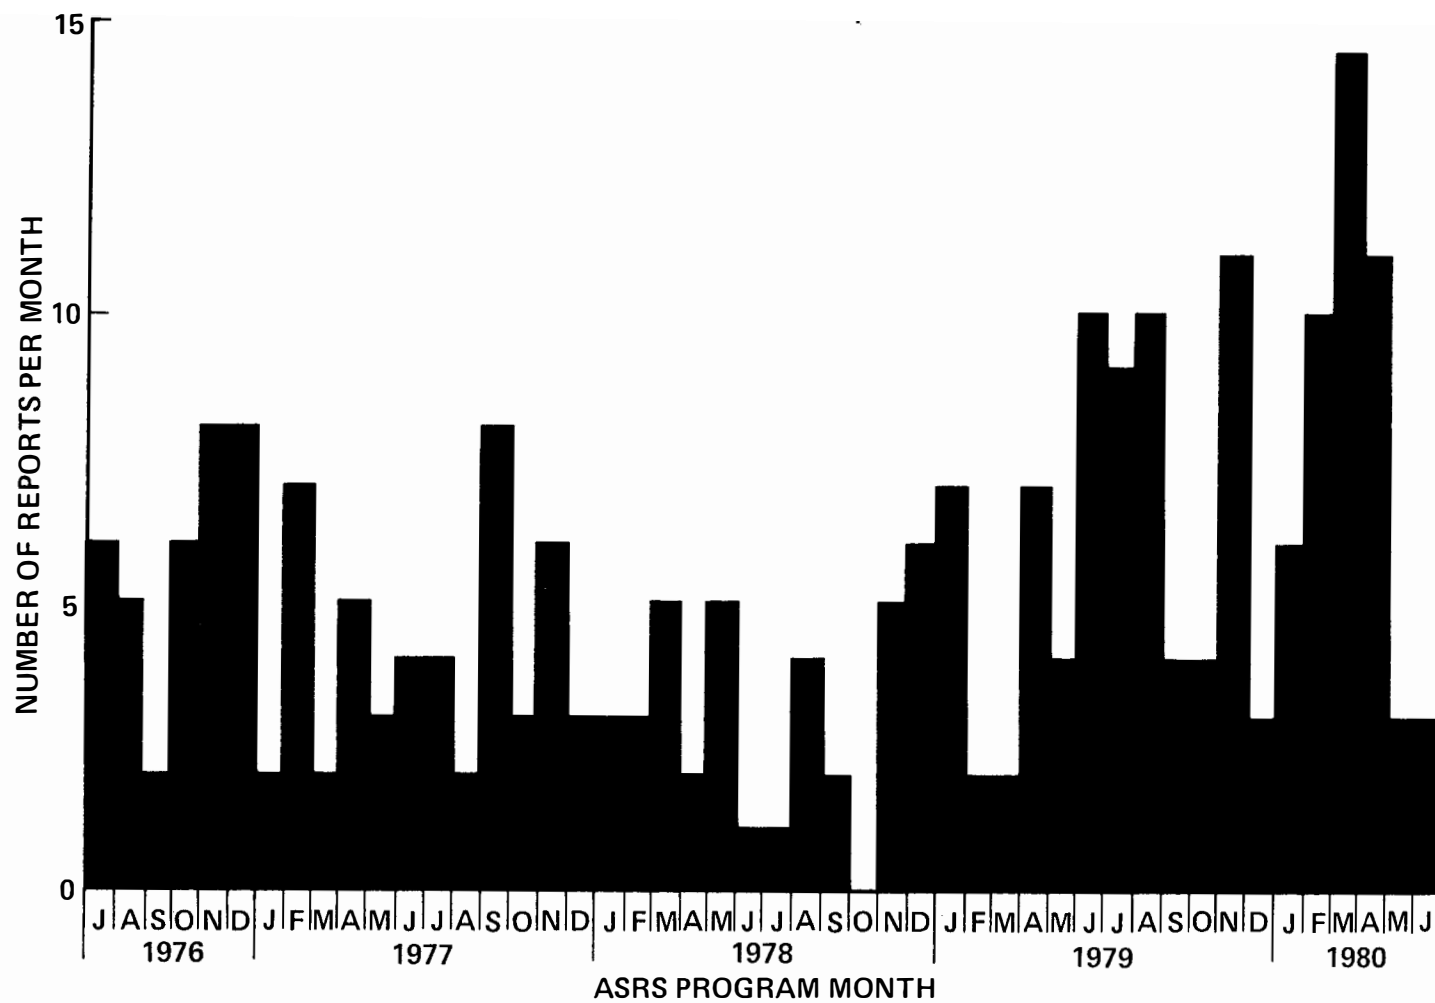
Figure 1.— Monthly receipts of ASRS reports associated with briefing of relief.

Figure 1 shows the number of ASRS reports, received since July, 1976, that were associated with the briefing of controller reliefs. There was a gradual decrease in reports until October 1978, the only month during which no reports were received. Since that time the number of these reports has tended to increase slightly, but this is not considered to be statistically significant since these reports comprise less than 1% of the total database. The increase may be attributable to recent changes in the immunity feature of the ASRS program, which fostered multiple reporting of the same occurrence.

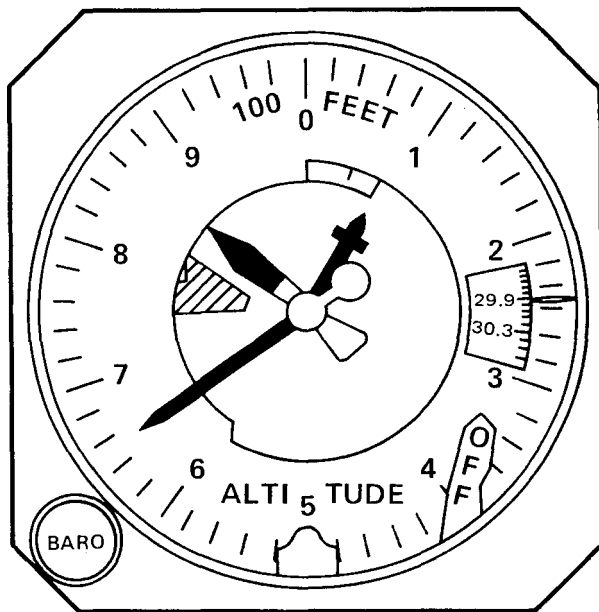
Figure 1.— Three-pointer altimeter.

A typical "three-pointer altimeter" is shown in figure 1. The three progressively shorter needles denote altitude in 100-, 1,000-, and 10,000-ft intervals, respectively. Each complete revolution of the 100-ft pointer indicates a change in altitude of 1,000 ft, as indicated by the 1,000-ft pointer. The shortest 10,000-ft needle is incremented one unit with each complete revolution of the 1,000-ft pointer.

Kollsman windows appear on all four instruments and display barometric pressure reference settings in either millibars or inches of mercury or both. Adjustments are made by means of the small knob on the front of the instrument cases.

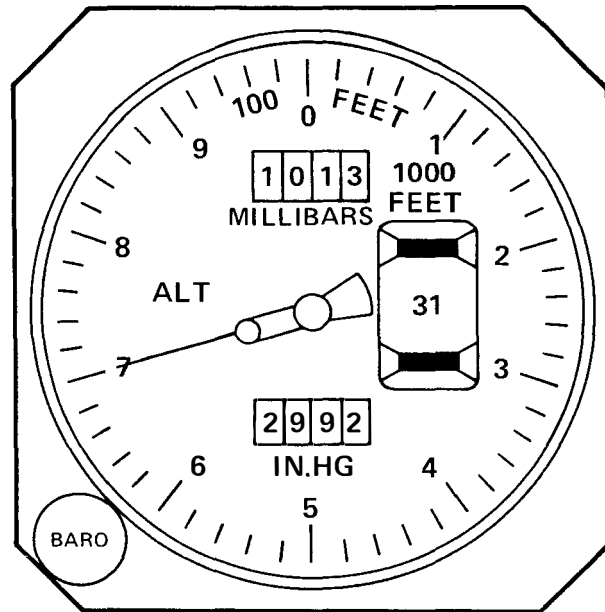
Figure 2.— Drum-pointer altimeter.

A "drum-pointer-type altimeter" is shown in figure 2. To the right of center of this instrument is a window containing two rotating counters which indicate feet in units of thousands and ten-thousands. Each complete revolution of the single pointer increments altitude by 1,000 ft. Whenever the aircraft is below 10,000 ft, a yoke flag appears over the innermost counter.

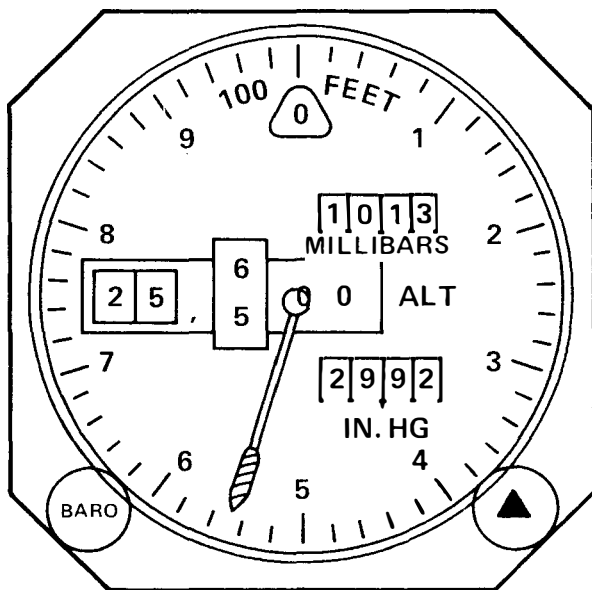
Figure 3.— Counter-drum-pointer altimeter.

Typical "counter-drum-pointer and counter altimeters" are illustrated in figures 3 and 4. Precise altitude tracking is maintained by means of the single pointer; a five-place numeric readout is available on the dial face for quick altitude reference. The basic design of these two instruments is similar, except that newer counter-pointer altimeters employ a snap-type action to rotate the digits; the counter-drum-pointer retains an analog motion with an expanded hundreds window to permit correct interpolation to the nearest hundreds place.

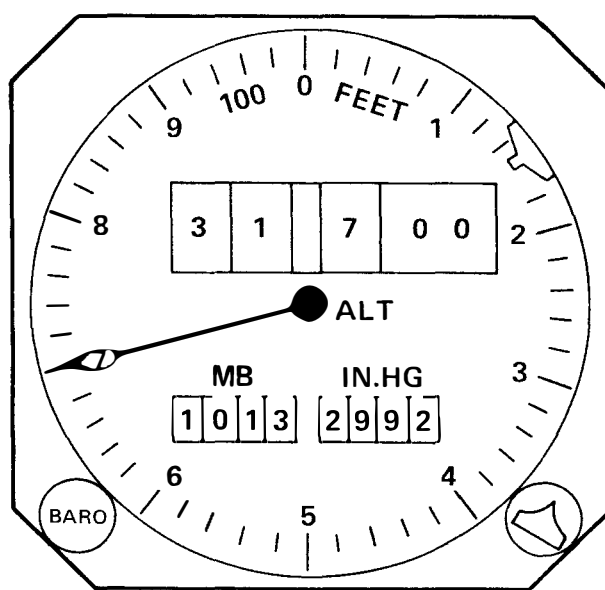
Figure 4.— Counter-pointer altimeter.
